Co-UDlabs

Webinar on Key findings from Co-UDlabs research and where to access them

Session II – Evaluation of Assets and Deterioration in urban drainage systems

Damage scenarios

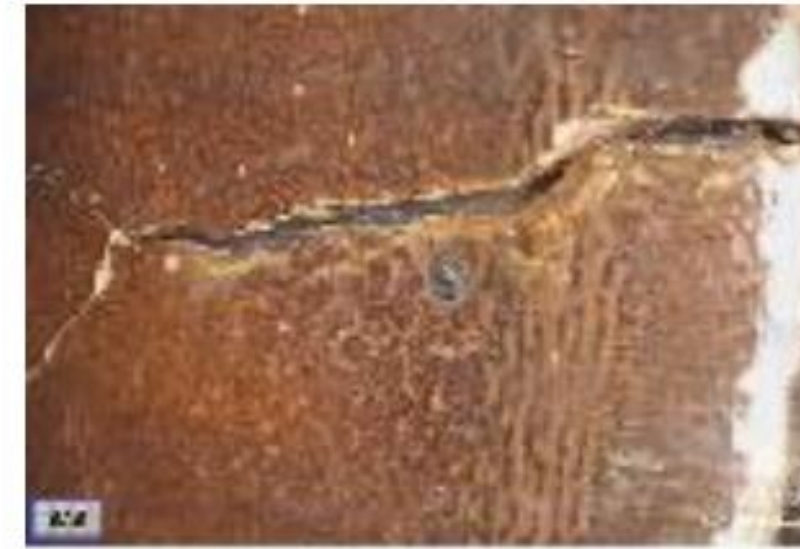
1.2 Fissure (Code: BAB)

(Source: MKULNV, 2014)
Cracks or fracture is visible.

fissure / crack

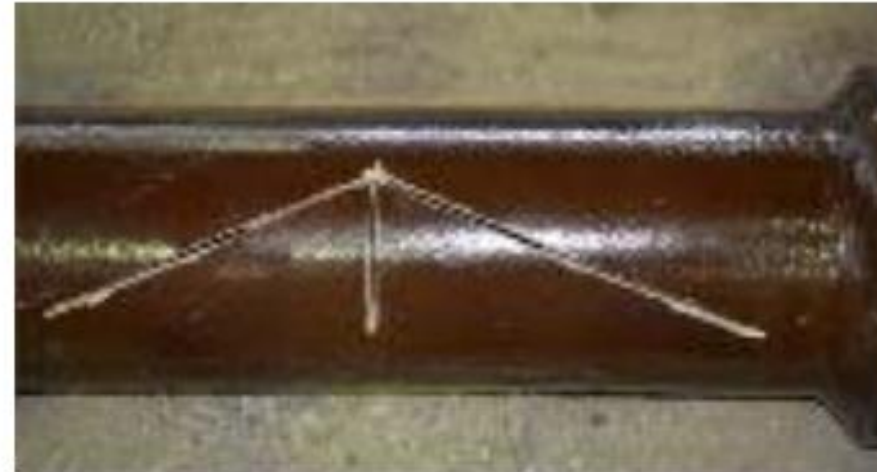
requirement profile: **rehabilitation
of house connection pipes using
(CIPP-) short liners**

stoneware pipe, expansion: 45 x 10
cm, crack width: 4 mm

(IKT, 2018)

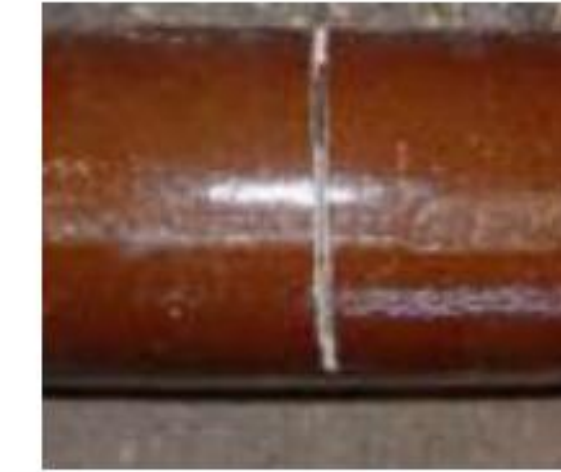
requirement profile:
**inspections systems for
property drainage**

stoneware pipe DN 100,
transverse crack, length
approx. 20 cm

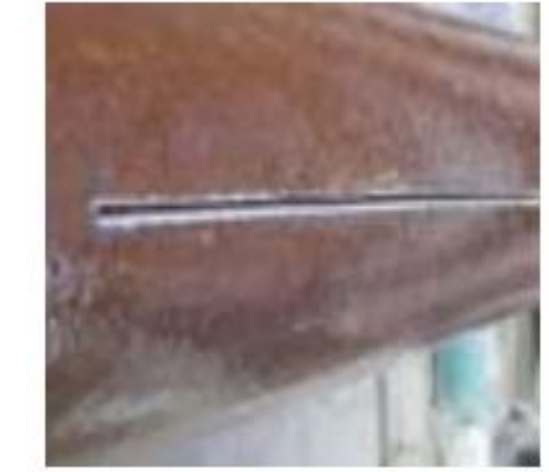
requirement profile:
**inspections systems for
property drainage**

stoneware pipe DN 100,
longitudinal crack, length
approx. 30 cm

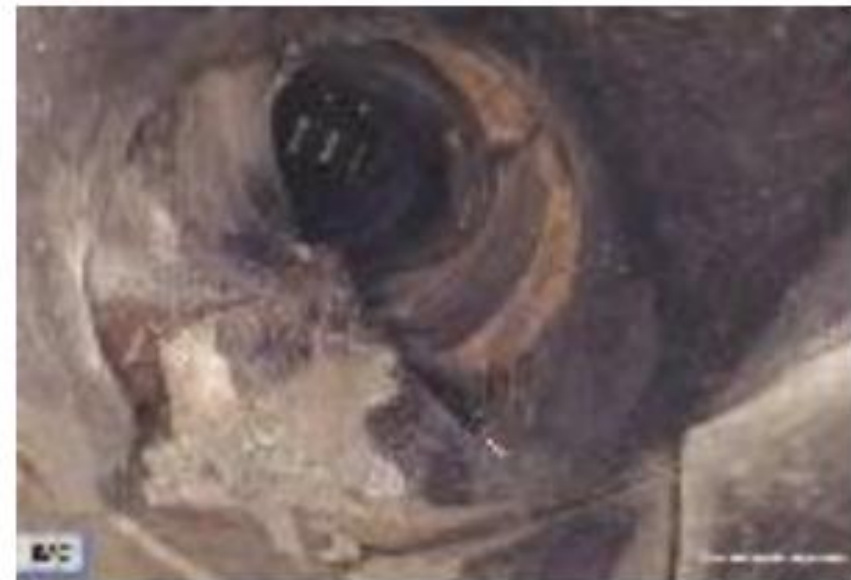
1.3 Break / Collapse (Code: BAC)

The pipe is broken or has collapsed.

Break / collapse

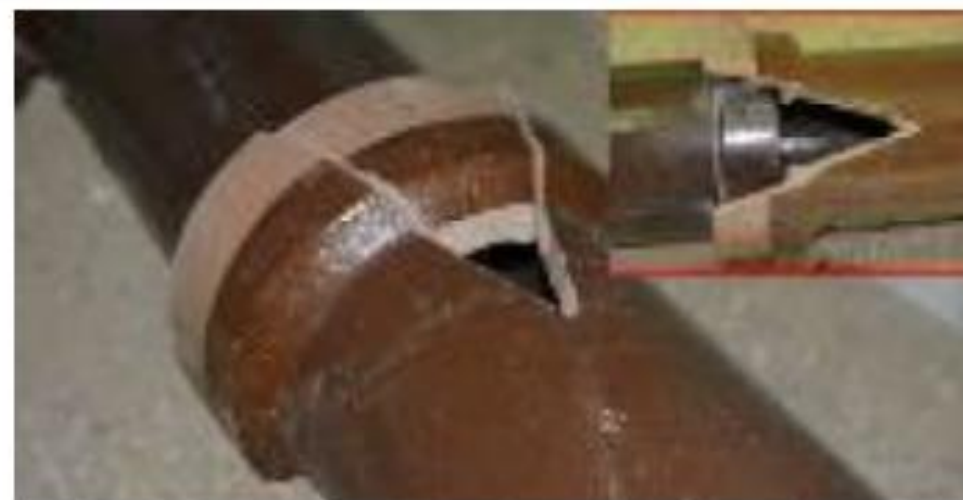
requirement profile: **Rehabilitation of house connection pipes using (CIPP-) short liners**

Stoneware pipe, expansion in longitudinal direction: 25 cm, piece of spigot end is inserted

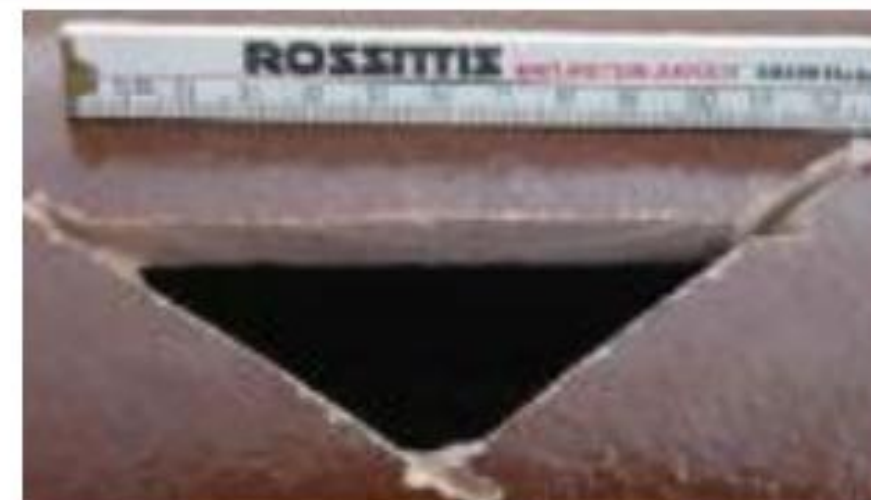
requirement profile: **Rehabilitation of house connection pipes using (CIPP)-short liners**
stoneware pipe DN 150, missing shard (approx. ½ x 10 x 5 cm)

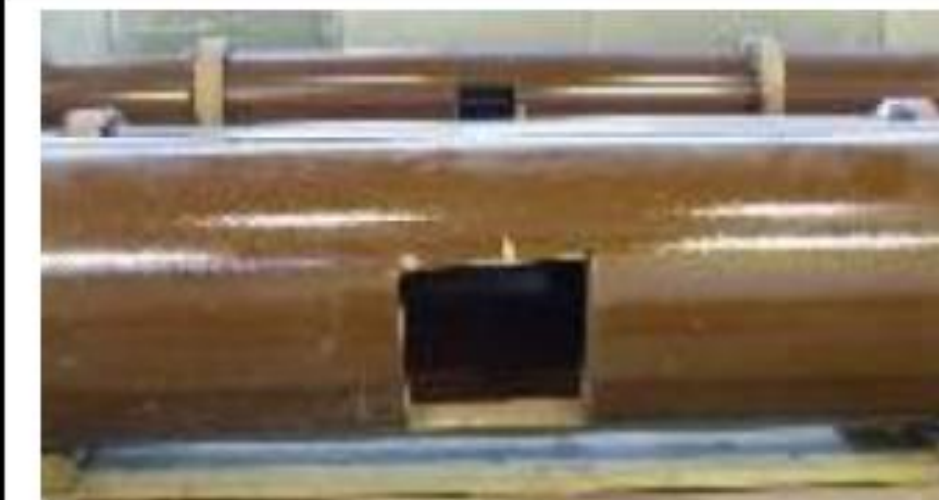
requirement profile: **Repairing methods for sewers (DN 200 – DN 600)**

stoneware pipe DN 200, breakout in the middle of the pipe below the springline (approx. 20 x 20 cm

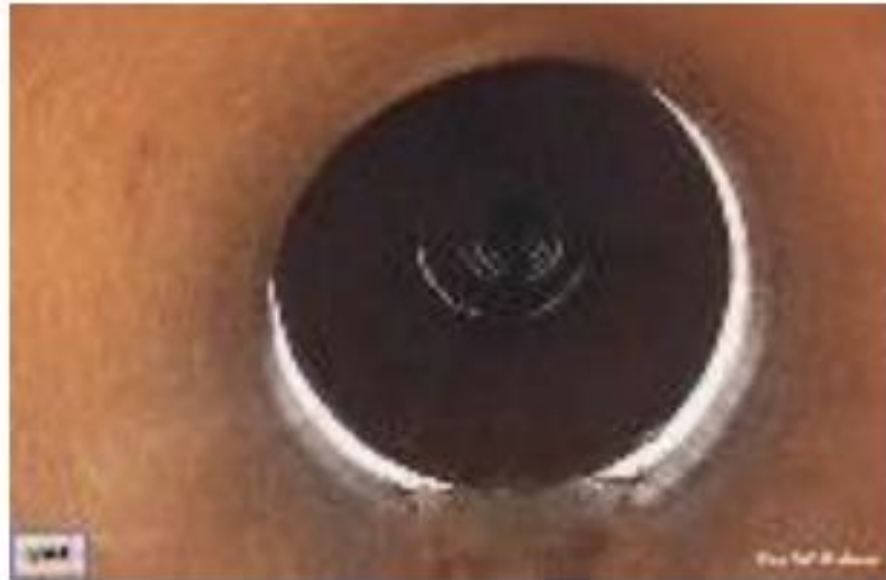
1.10 Displaced joint (Code: BAJ)

displaced joint

description according to EN 13508-2: Adjacent pipes are displaced from their intended position in relation to each other.

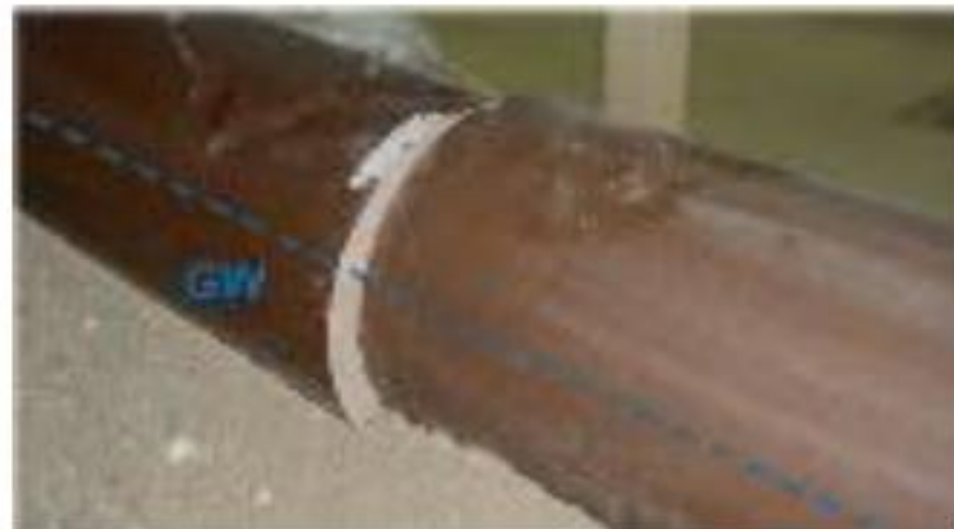
Requirement profile: **rehabilitation of house connection pipes using (CIPP-)short liners**

Expansion: ≥ 20 mm,
rehabilitation under groundwater inflow
at approx. 50% of the pipe height

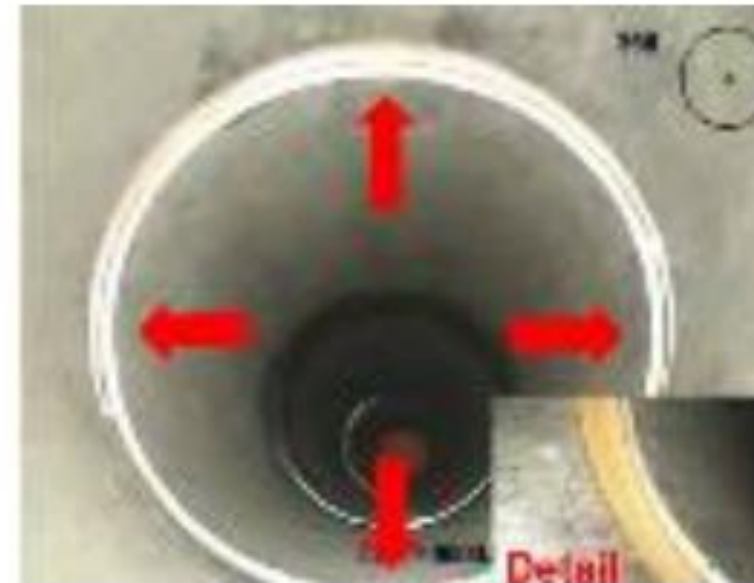
Requirement profile: **rehabilitation of rising mains axially displaced socket joint, with 31 mm longitudinal offset (circumferential)**
(Bosseler/Ulutas, 2022)

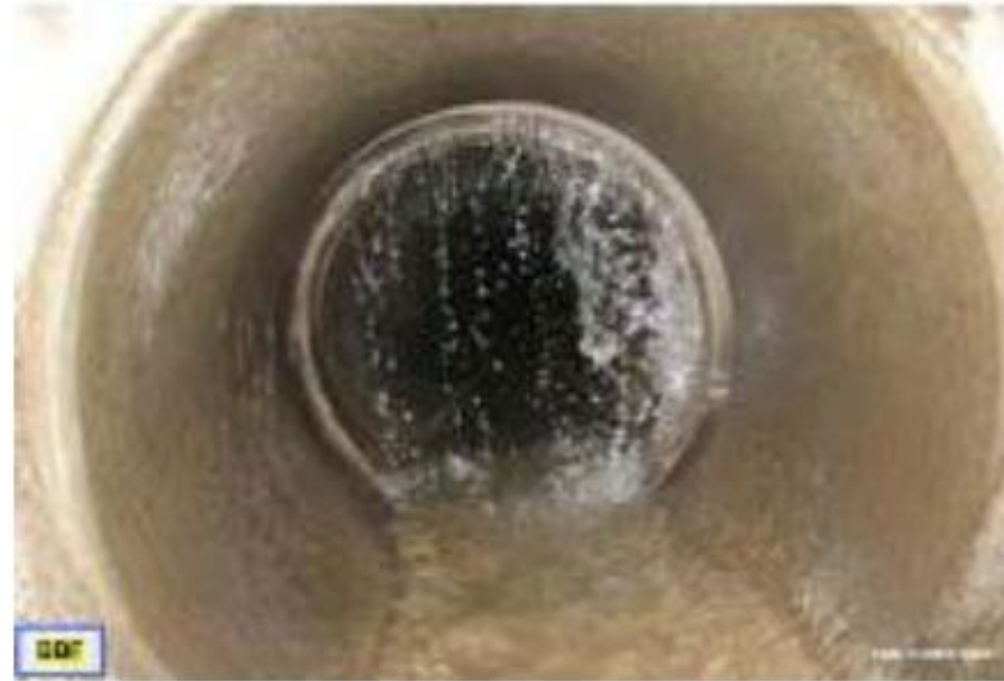
1.18 Infiltration (Code: BBF)

infiltration

description according to EN 13508-2: The ingress of water through the wall of the pipe or through joints or defects.

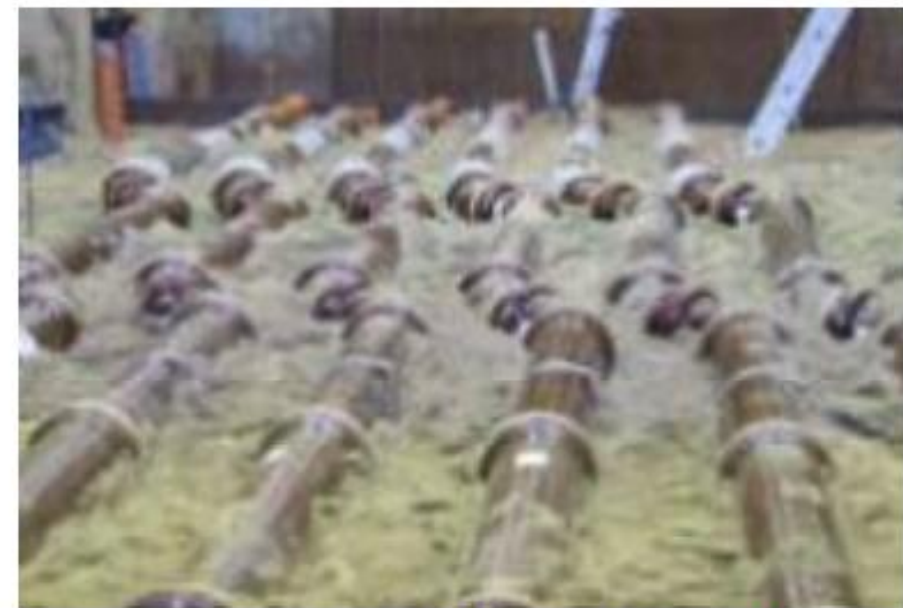
Requirement profile: testing **CIPP liners for house connection**
(Bosseler/Redmann, 2010)

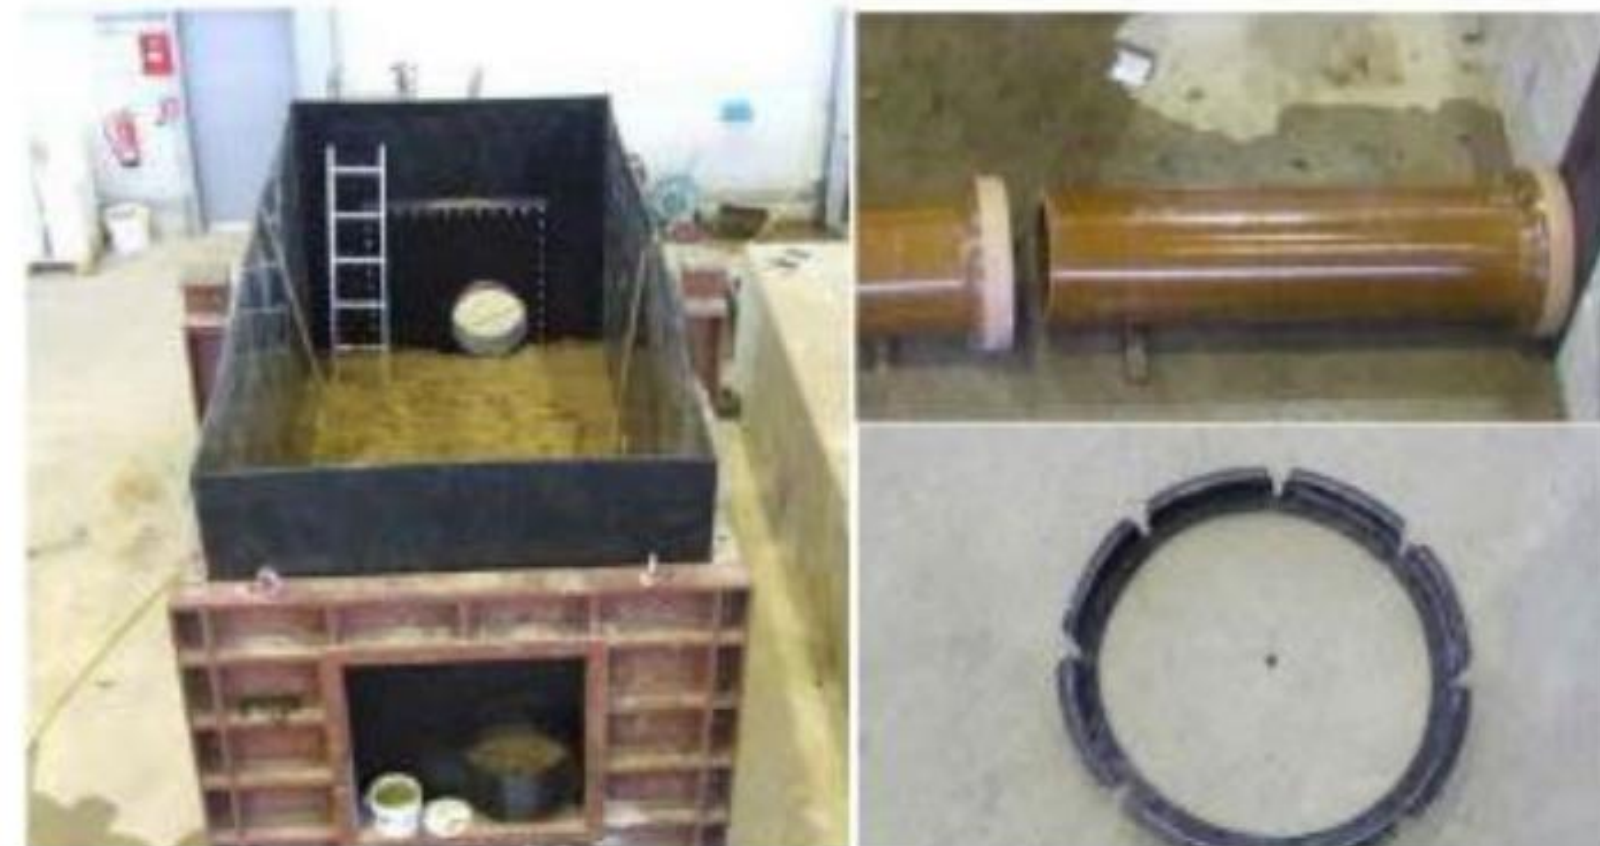
displaced joint

Input / idea: creating defect „**damaged sealing**“ at pipe joint and „**displaced joint**“

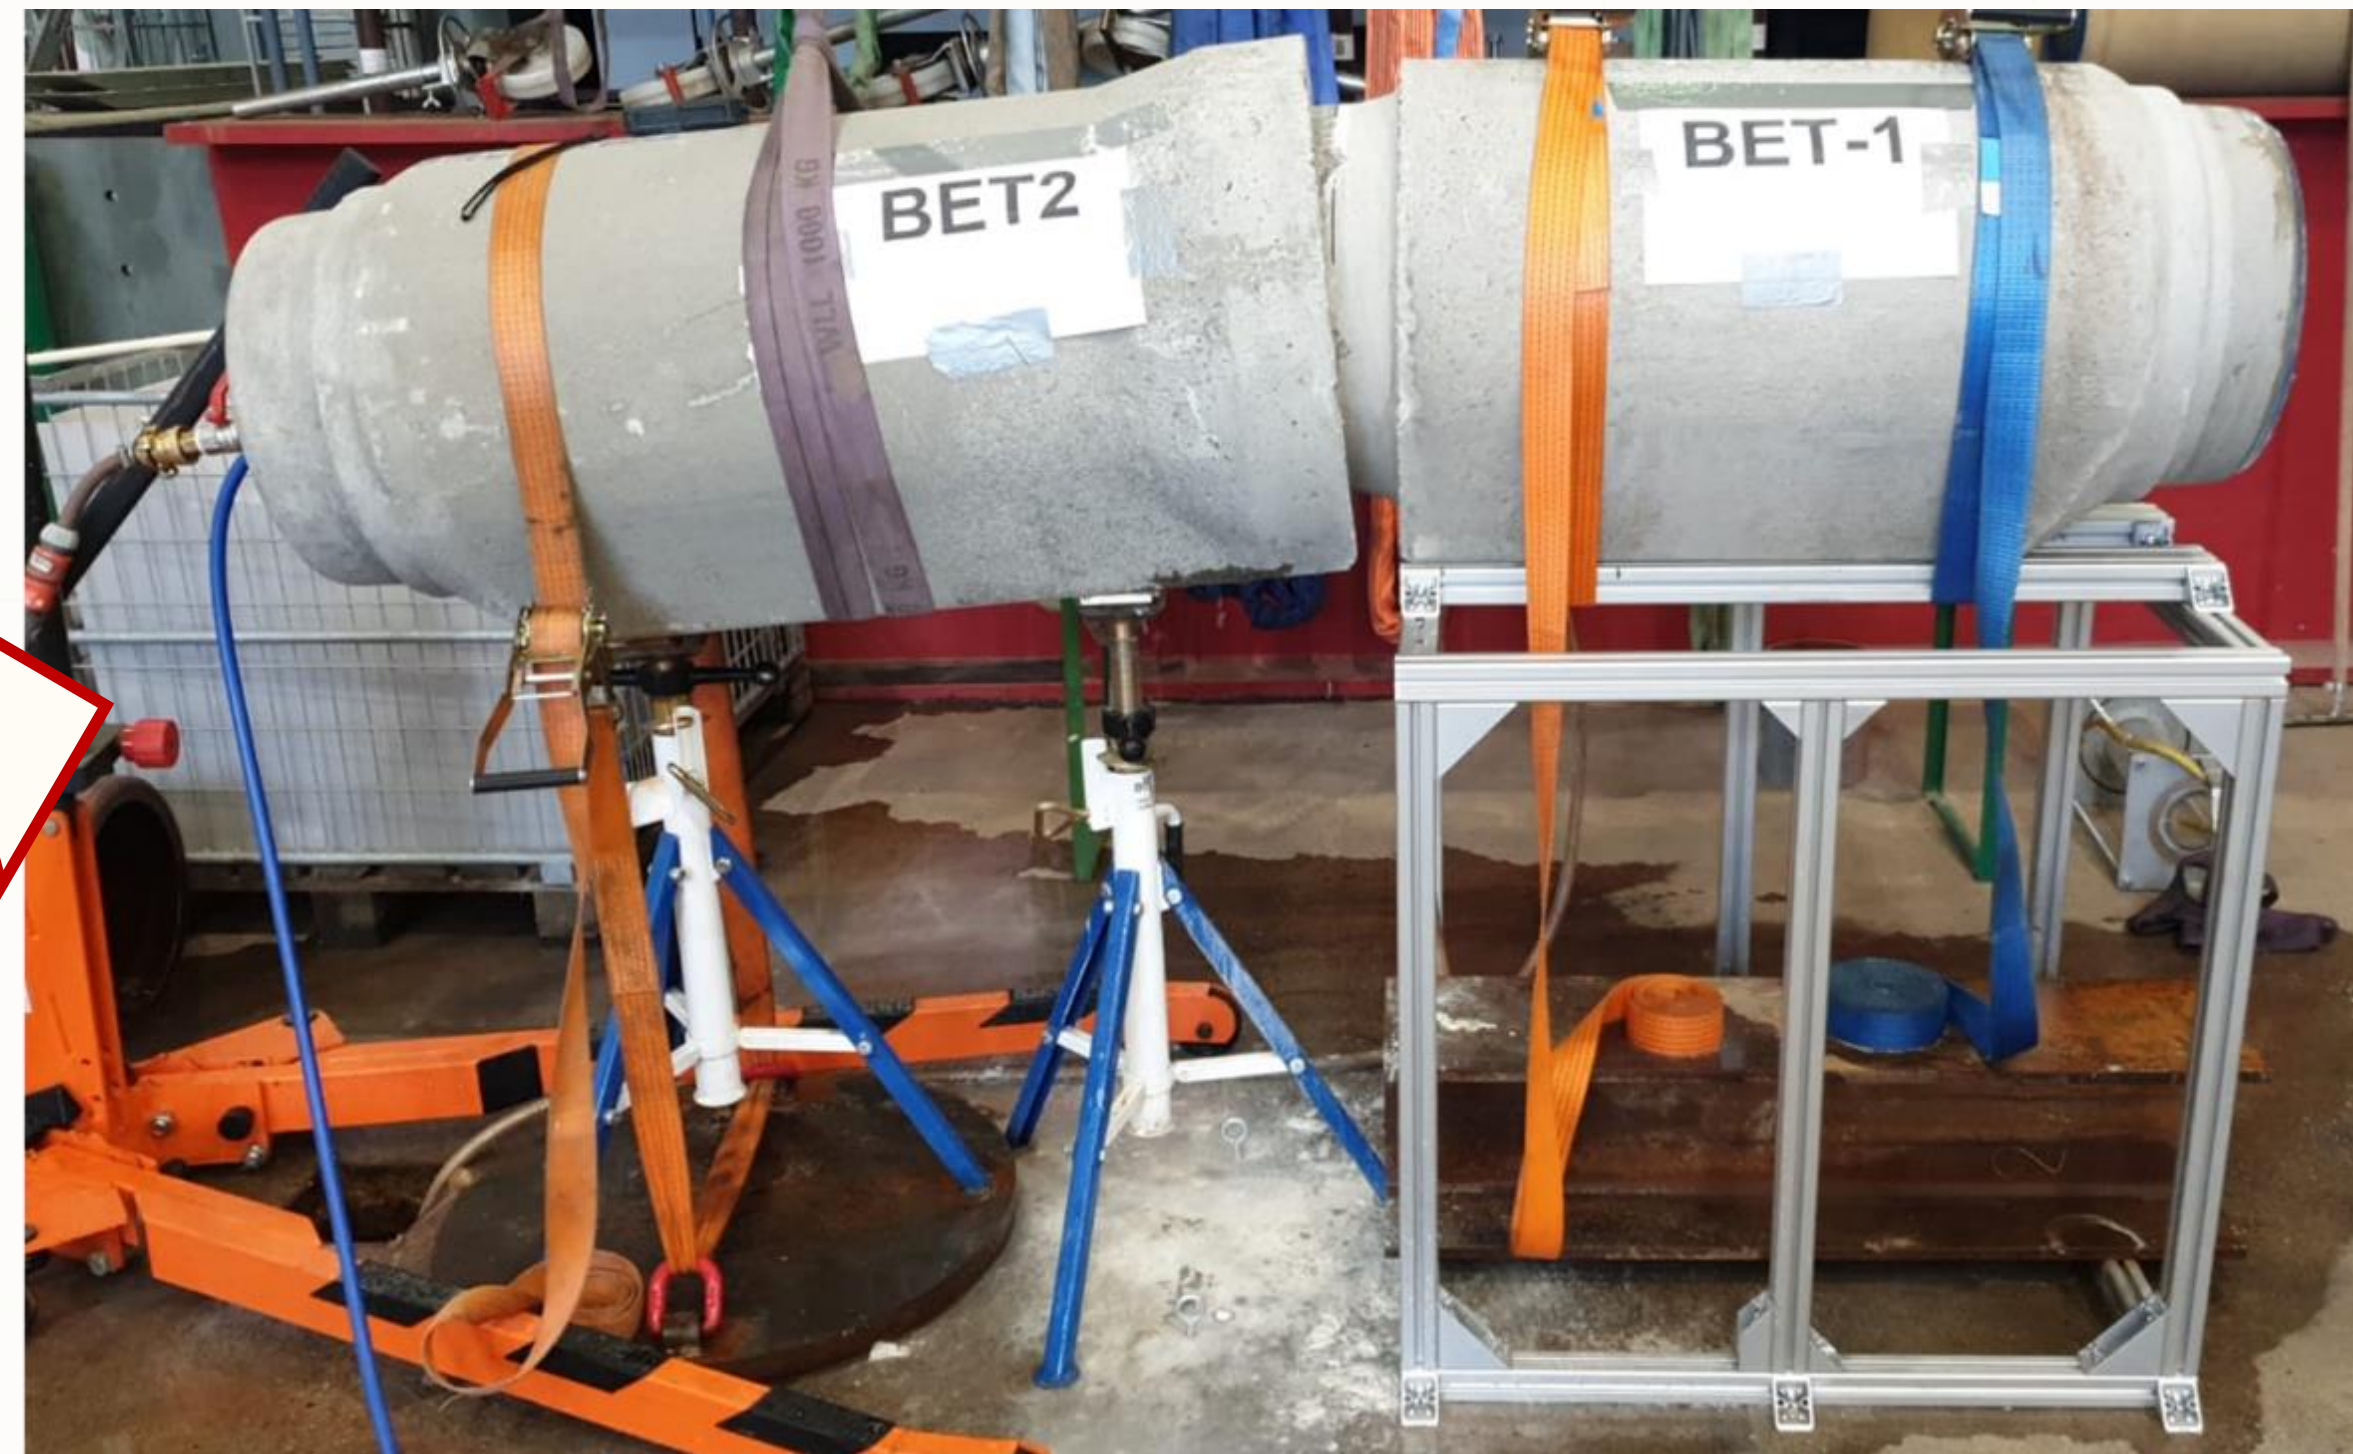
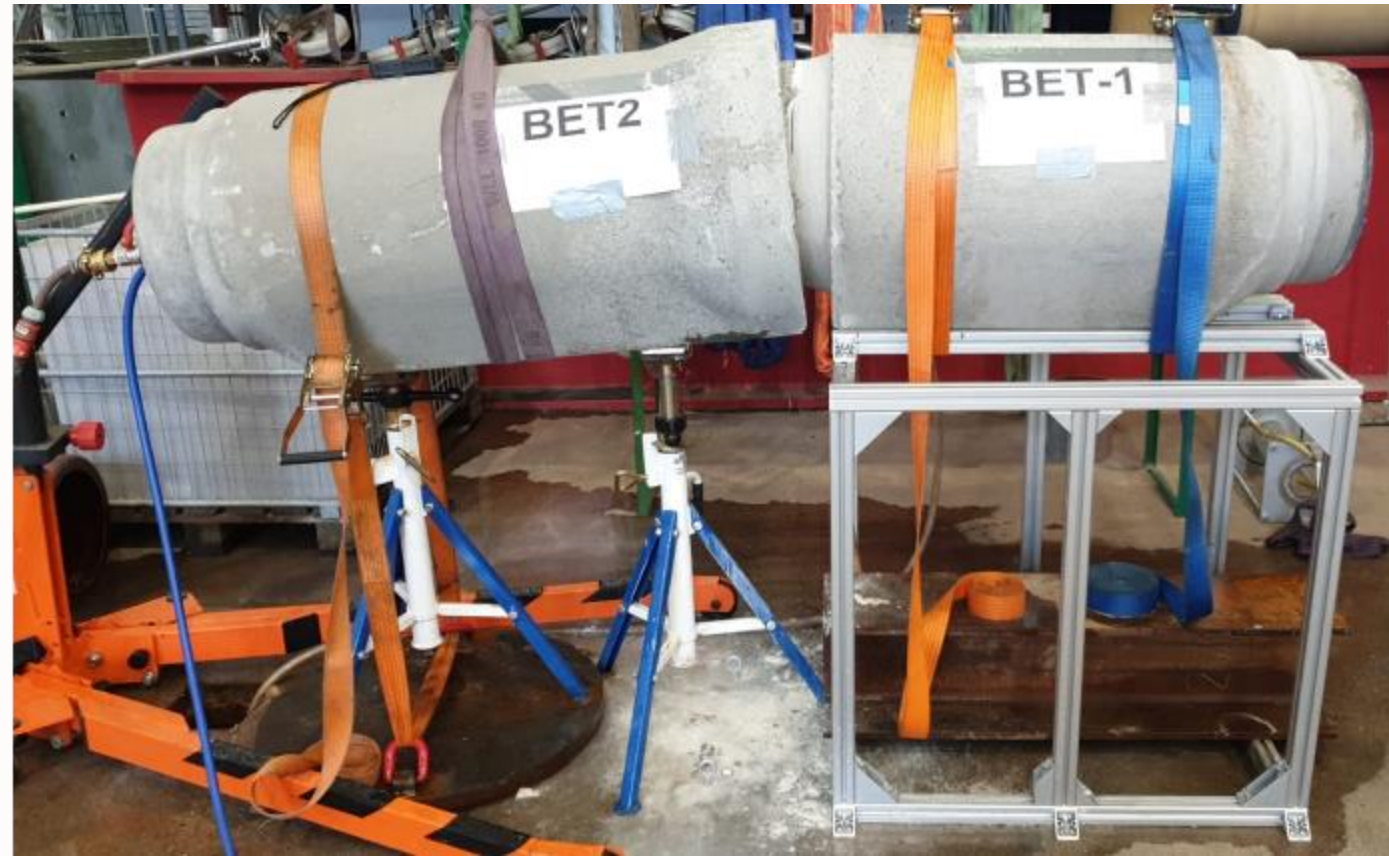
Lab exfiltration test setup at IKT

1) Pipe joint displacement at IKT without surrounding soil

Measuring water exfiltration rate under change of conditions:

- pipe material: concrete, clay and PVC
- varying angles at pipe joint
- with and without damaged sealing

=> in-air exfiltration test (IKT) could be used to estimate exfiltration rates from articulated pipes (with and without damaged seal at joints)

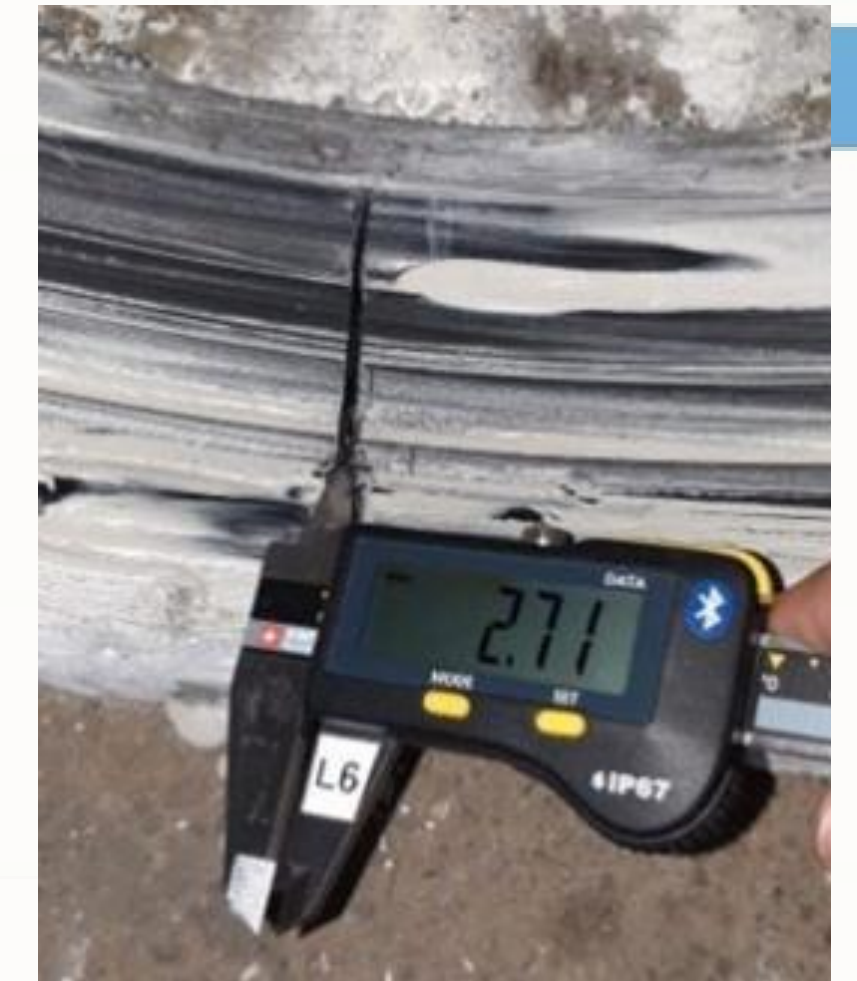
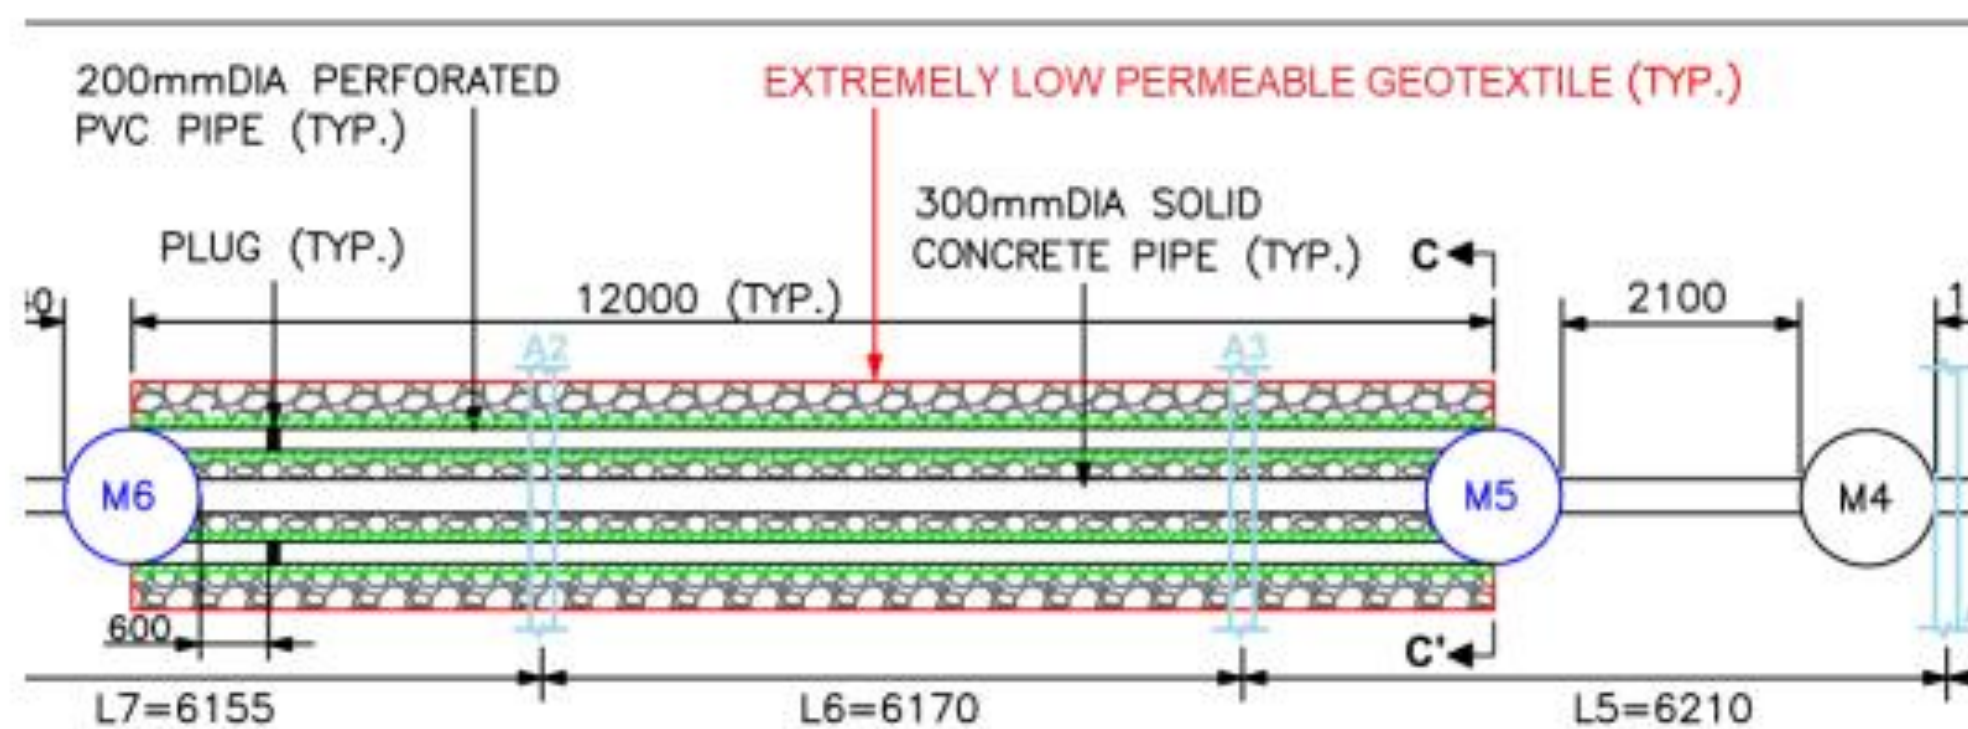
2) Pipe joint displacement at UoS with surrounding soil

Measuring water exfiltration rate under conditions:

- pipe material: concrete
- Surrounding soil
- Load to create pipe joint displacement

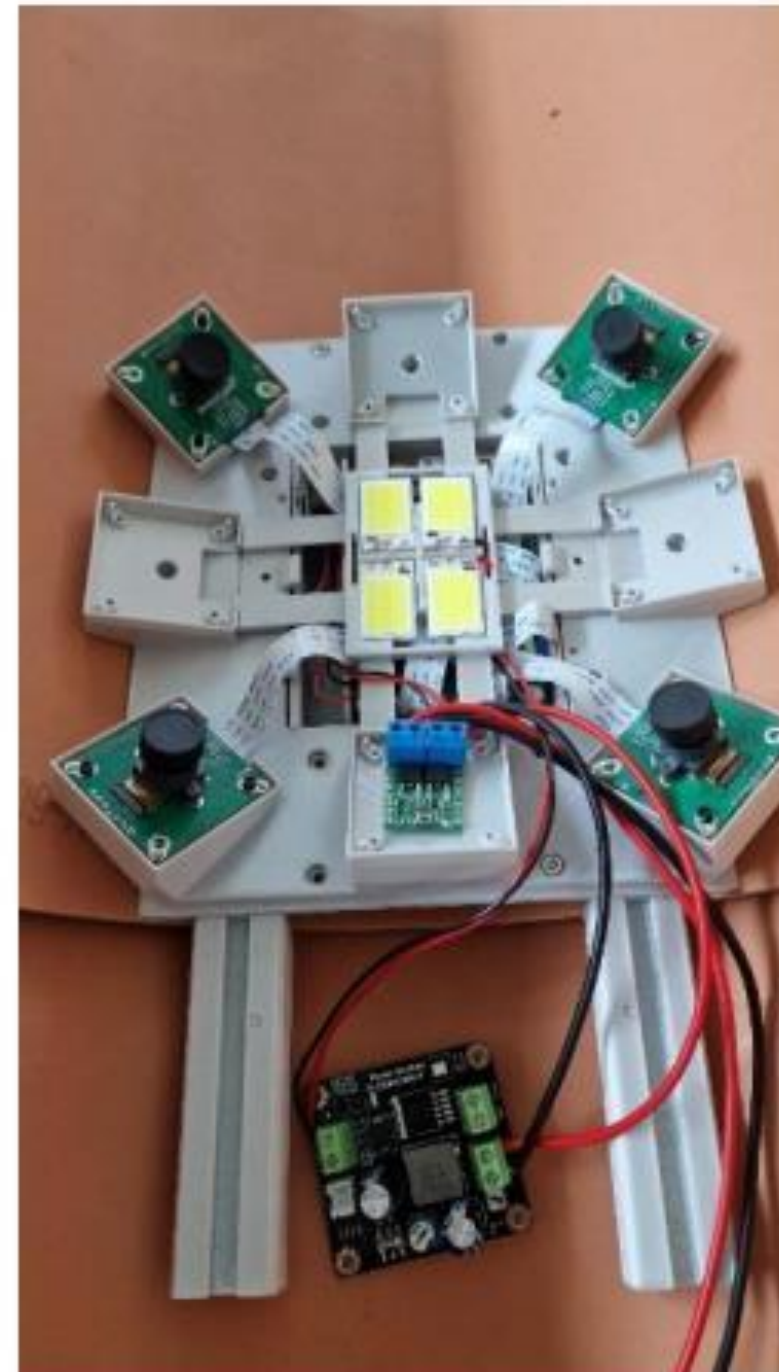
3) Development and demonstration of In-pipe joint displacement measurements (DIC-system of UoS)

Digital Image Correlation (DIC) – based on the analysis of changes between images taken before and after deformation of a target surface of its spatial and optic characteristics

Development and optimization at UoS
Demonstration at lab exfiltration test setup at IKT
